AI-AEC-12670

AEC Research and Development Report

HELIUM EMBRITTLEMENT
OF
TYPE 316 STAINLESS STEEL

CONTRACT: AT(04-3)-701
ISSUED: APRIL 30, 1968

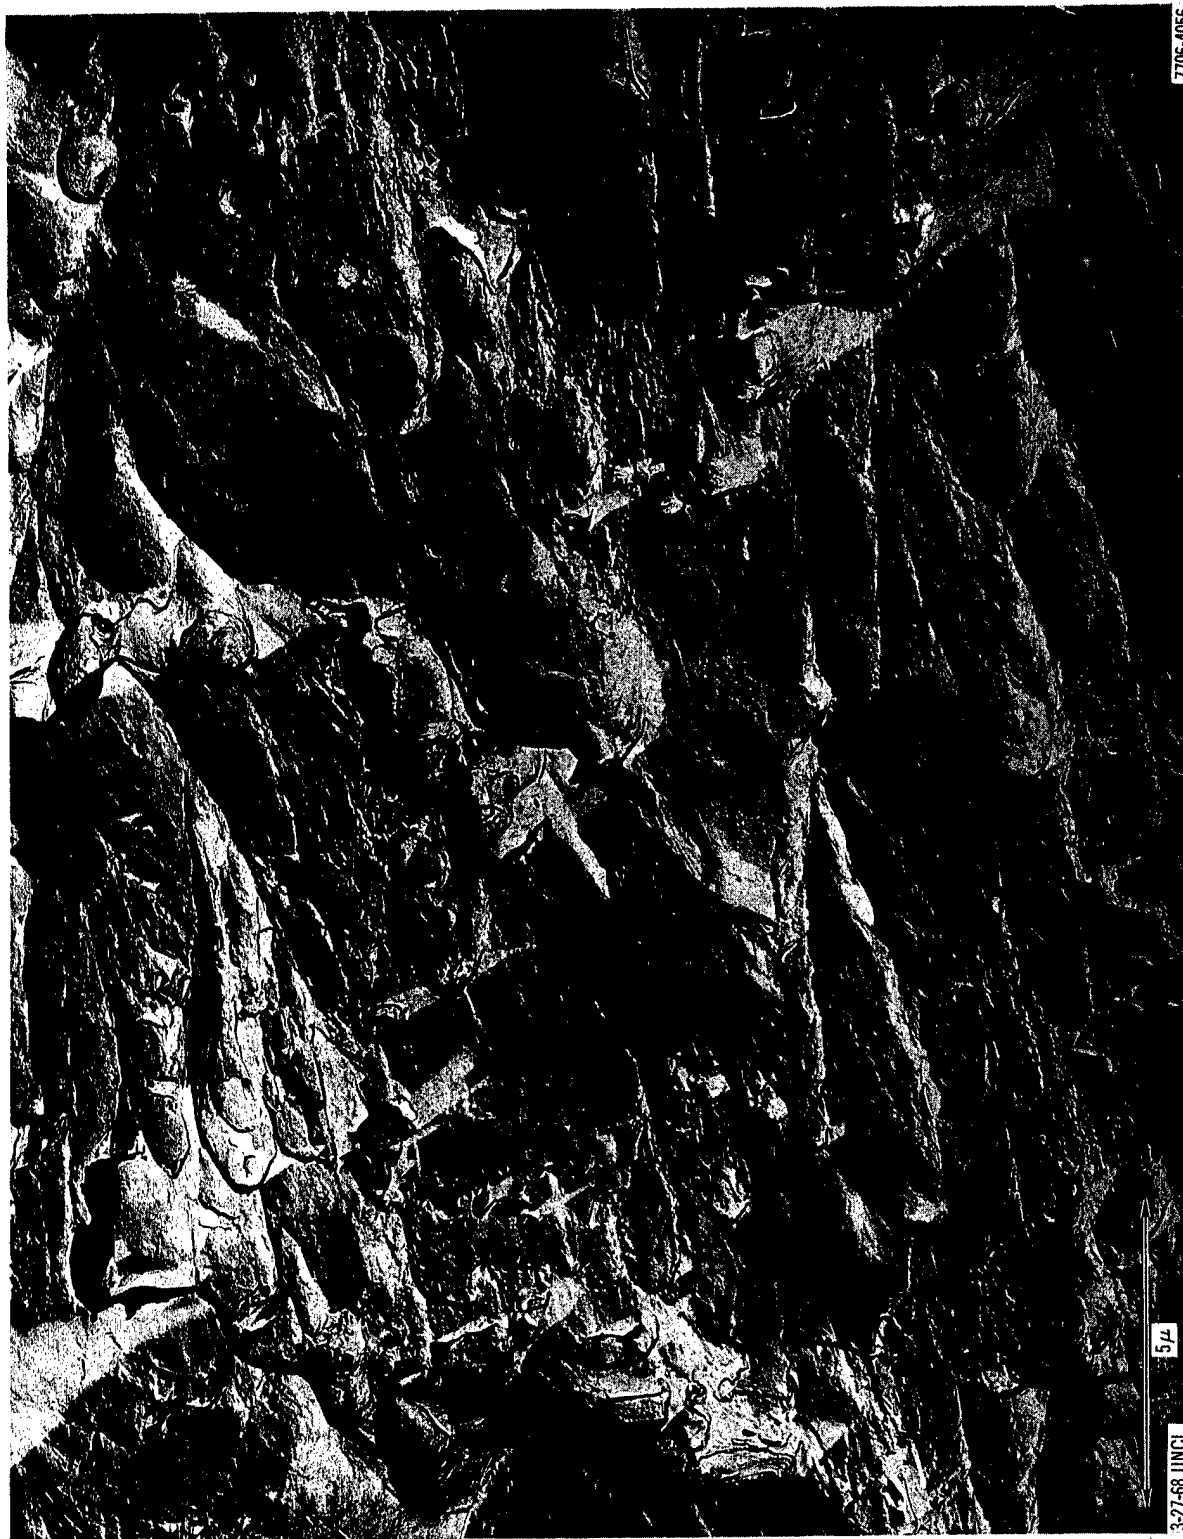
At 540°C all samples given either treatment with or without He failed transgranularly. The mechanism of shear-rupture was operating as evidenced by the shear-rupture dimples in Figure 5 which typifies all fractographs of samples tested at this temperature. The mode of failure of samples given Treatment 13 with or without He, and of samples given Treatment 6 without He was transgranular at 650°C. However, samples given Treatment 6 with He showed a mixture of transgranular and intergranular failure.

Figure 5. Fractograph of Type 316 Stainless Steel Without Helium
Tested at 540°C, Showing Shear-Rupture Dimples

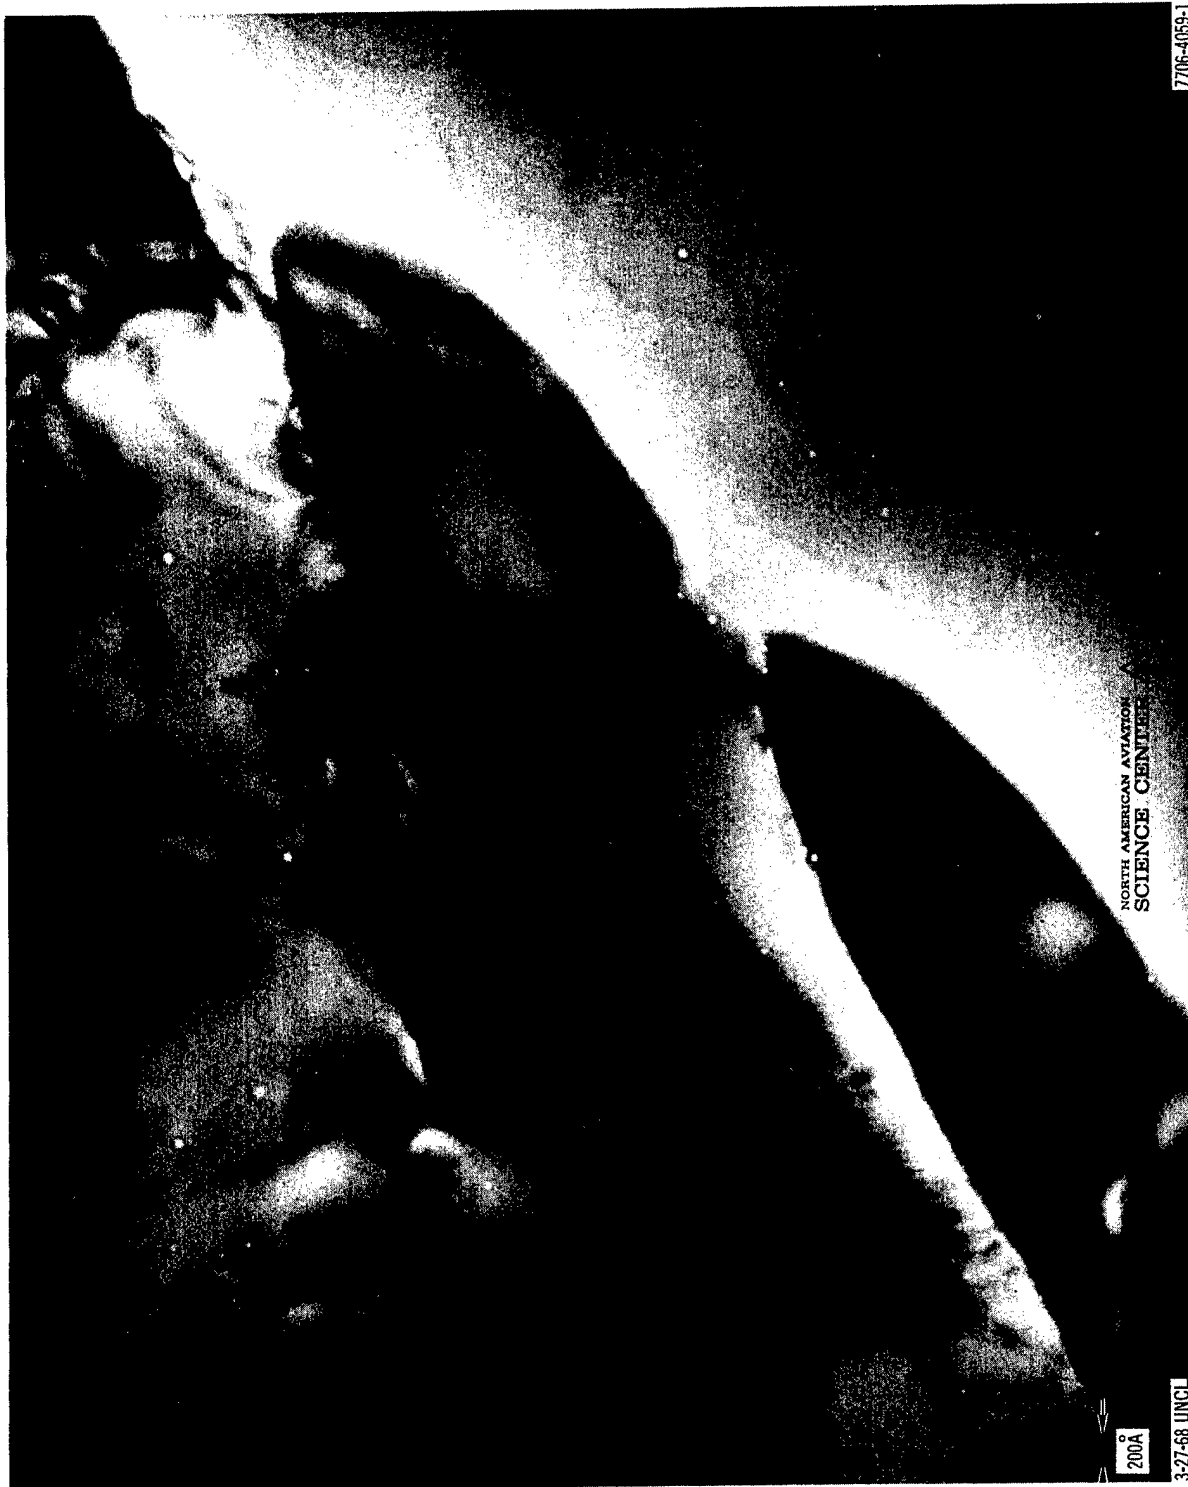
Helium bubbles were found in samples given either treatment after testing at 760°C (bubbles were not detected after tests at 540 and 650°C) and were generally located on grain boundaries, dislocations, and precipitates. Figure 8 shows He bubbles in samples given Treatment 6. The average bubble size is less than 100 Å although some bubbles 1000 Å and greater are present on grain boundaries and attached to carbide particles (see Figure 8c).

Figure 8a. Transmission Electron Micrograph Showing Helium Bubbles
in Type 316 Stainless Steel Given Treatment 6 With 4 x 10⁻⁵
Atom Fraction Helium Tested at 760°C

Figure 8b. Transmission Electron Micrograph Showing Helium Bubbles
in Type 316 Stainless Steel Given Treatment 6 With 4×10^{-5}
Atom Fraction Helium Tested at 760°C

Figure 8c. Transmission Electron Micrograph Showing Helium Bubbles
in Type 316 Stainless Steel Given Treatment 6 With 4 x 10⁻⁵
Atom Fraction Helium Tested at 760°C

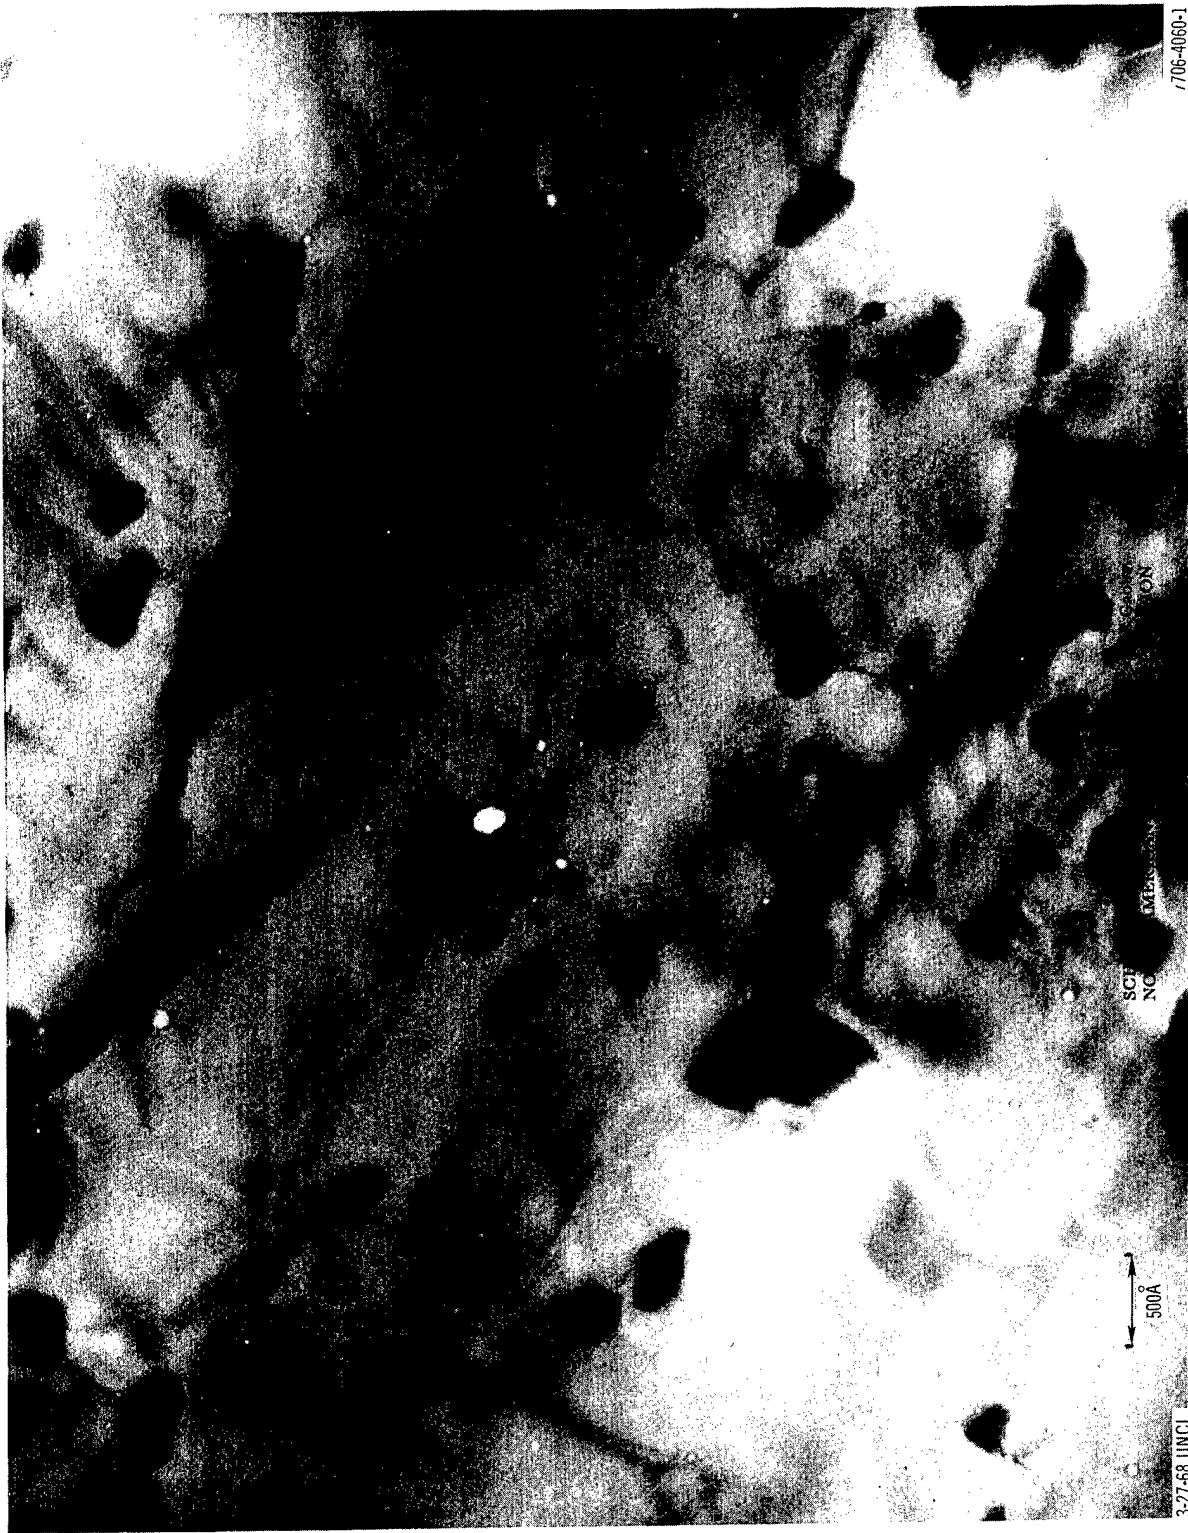
Figure 9 shows He bubbles in samples given Treatment 13. Their average size is also less than 100\AA but a very large bubble ($>2000\text{\AA}$ in one dimension) has formed on a grain boundary (see Figure 9b). Most of the small bubbles are attached to σ -particles. Large bubbles were significantly less prevalent in samples of Treatment 13 than in 6.

Figure 9a. Transmission Electron Micrograph Showing Helium Bubbles
in Type 316 Stainless Steel Given Treatment 13 With 4×10^{-5}
Atom Fraction Helium Tested at 760°C

Figure 9b. Transmission Electron Micrograph Showing Helium Bubbles
in Type 316 Stainless Steel Given Treatment 13 with 4×10^{-5}
Atom Fraction Helium Tested at 760°C

Samples given Treatment 13 show loss of ductility beginning above 650°C, while at this temperature those given Treatment 6 have already lost more than half their ductility. This is due to the effectiveness of the high density of σ -particles (10^{13} cm^{-3}) in trapping He (seen in Figure 9a as bubbles attached to the particles), thereby delaying the accumulation of He at grain boundaries.
